State of California  
Department of California Highway Patrol

## 1989 Loma Prieta Earthquake Summary Report

# I-80 San Francisco-Oakland Bay Bridge and the I-880 Nimitz Freeway Collapse Summary

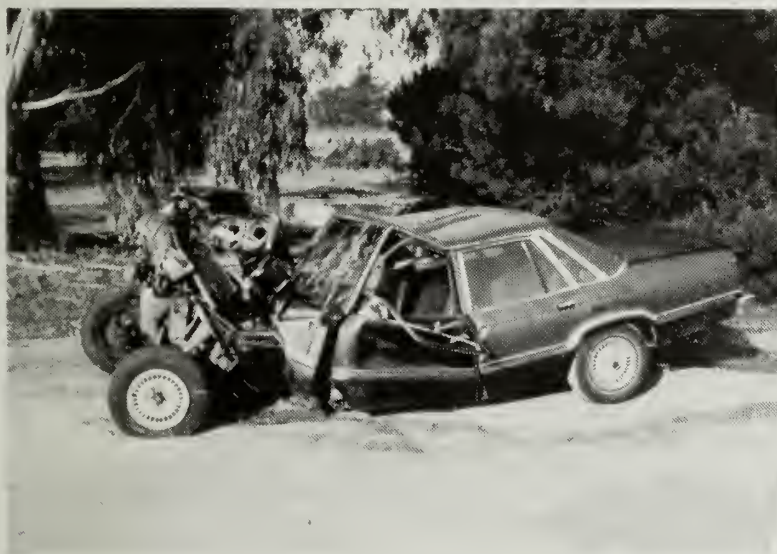
During the response of emergency personnel, lengthened by gridlocked traffic and thousands of persons out of their vehicles, a vehicle driven the wrong way (eastbound on the westbound top deck) ran off the upper deck and into the gap that had been created by the collapse of the fifty foot closure spans at tower E-9. The vehicle struck the east end of the collapsed westbound deck.

The damage to the interior of the vehicle on the driver's side indicated contact with the steering wheel and lower dash area. The steering column and wheel were forced upward. This is consistent with the continued forward movement of the driver as the vehicle came to a sudden stop.

The examination of the restraint system on the driver's side indicated it was not in use at the time of impact. This is also consistent with the injuries suffered by the driver and the observed damage to the interior of the vehicle. It is also consistent with the on scene CHP motorcycle Officer's observations of no seat belt on the driver as the vehicle was extracted from its precarious position.

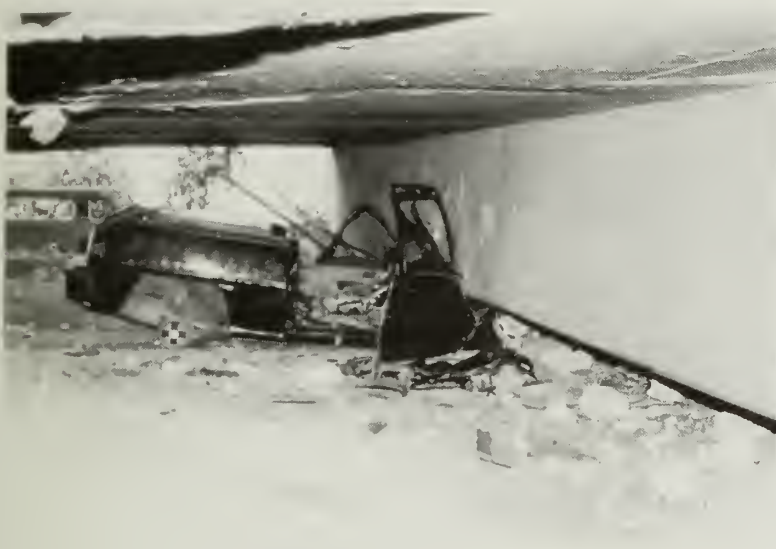
### V-97

Just prior to the earthquake, a 35 year-old female was driving a 1986 Dodge Colt northbound on I-880 in the N-2 lane at approximately 50 mph. The Colt was equipped with lap/shoulder harness type restraints in the left front and right front seats, and lap belt type restraints in the left rear, center rear, and right rear seats. The driver was utilizing her restraint.
